Subject: Clean Water Act Compliance Evaluation Inspection Report

**CWA COMPLIANCE EVALUATION INSPECTION REPORT
U.S. ENVIRONMENTAL PROTECTION AGENCY, REGION 5**

Facility: Calamity Knoll

Date of Inspection: April 24, 2014

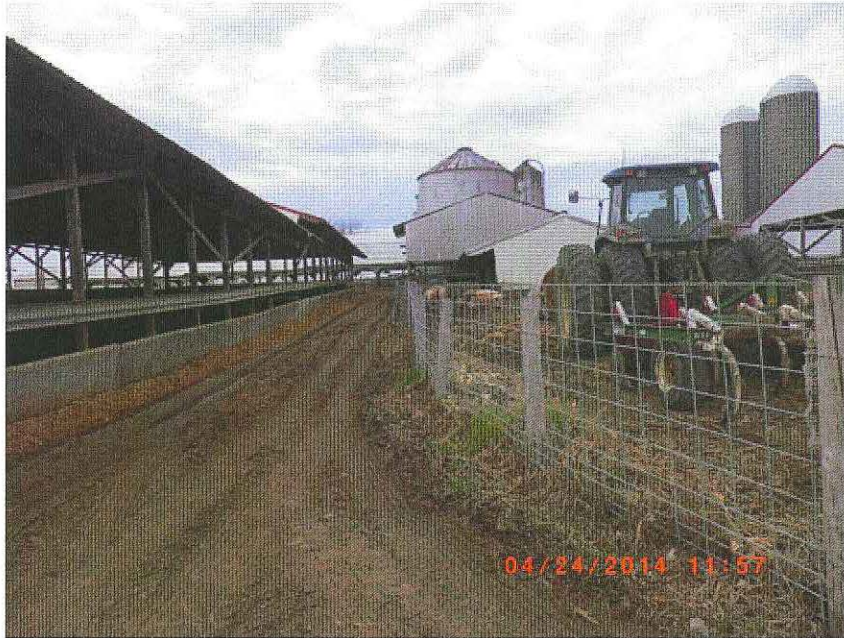
19: IMGP0645

Description: Open lots for pigs is sloped such that it drains to the east.

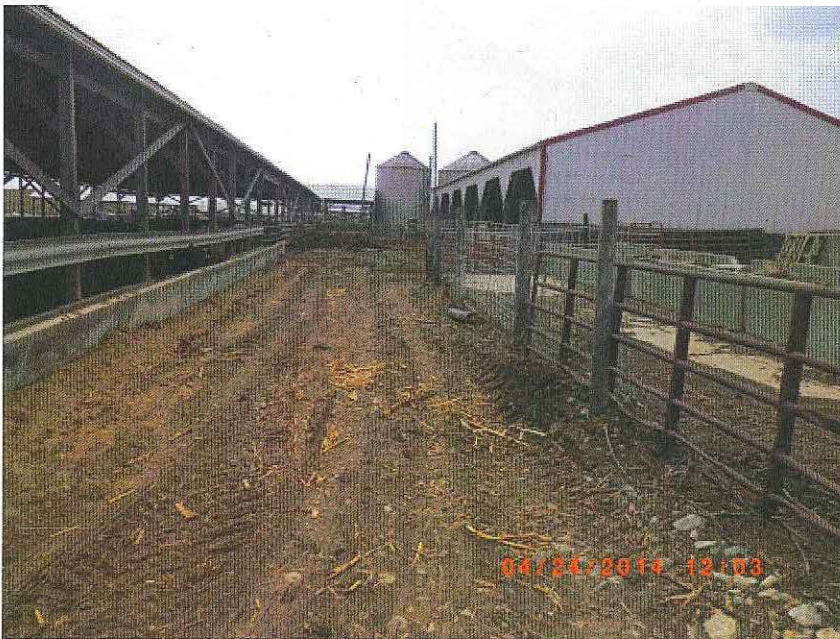
24: IMGP0650

Description: Pile of manure stacked west of the Bruce Barn. Open lots drained to the east.

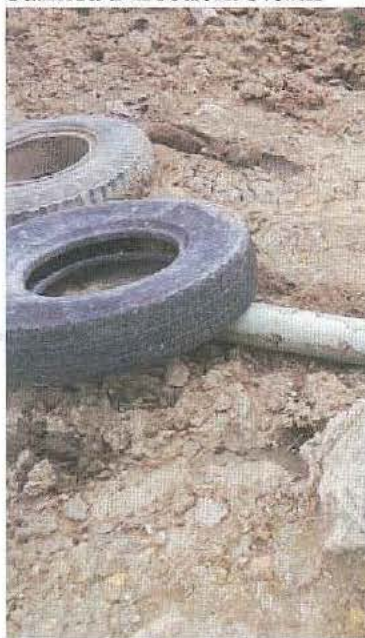
26: IMGP0652

Description: The bunker feed storage area drained through a pipe to an underground tank. The tank was full during the inspection. Any additional process wastewater flow to the tank would cause an overflow and flow east and then north to Spring Brook. The tire marks the inlet of the underground tank.

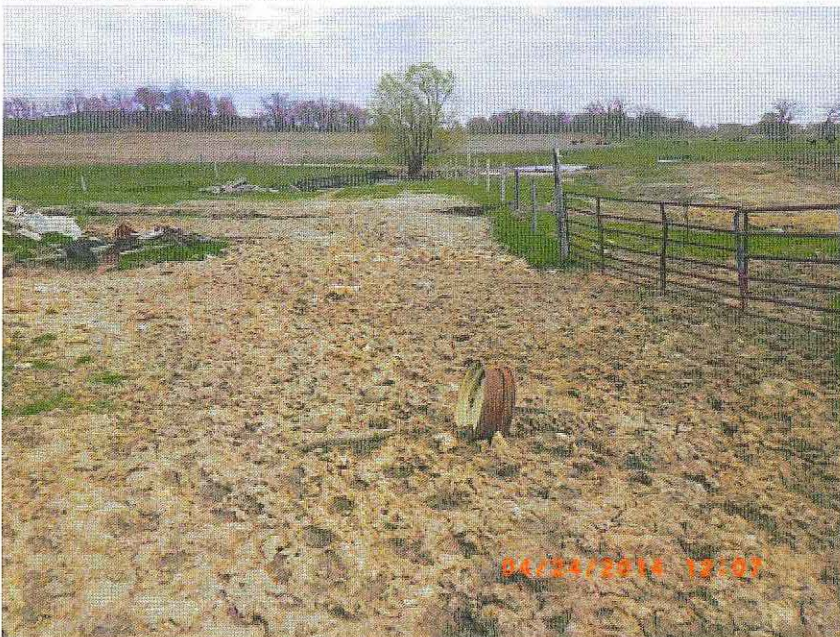
28: IMGP0654

Description: The feed storage bunkers drain east through this area that did not have any vegetation.

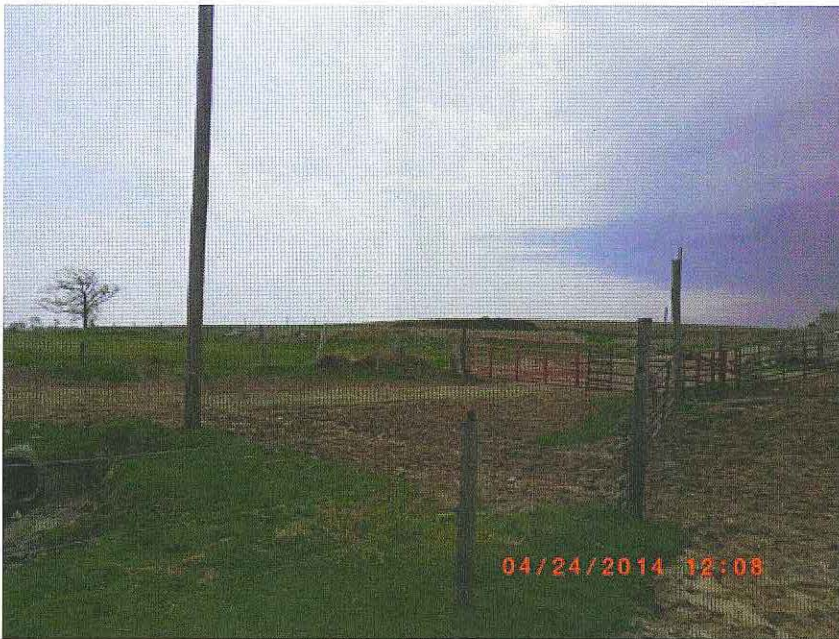
32: IMGP0658

Description: A compost pile was observed south of the Feed Bunkers.

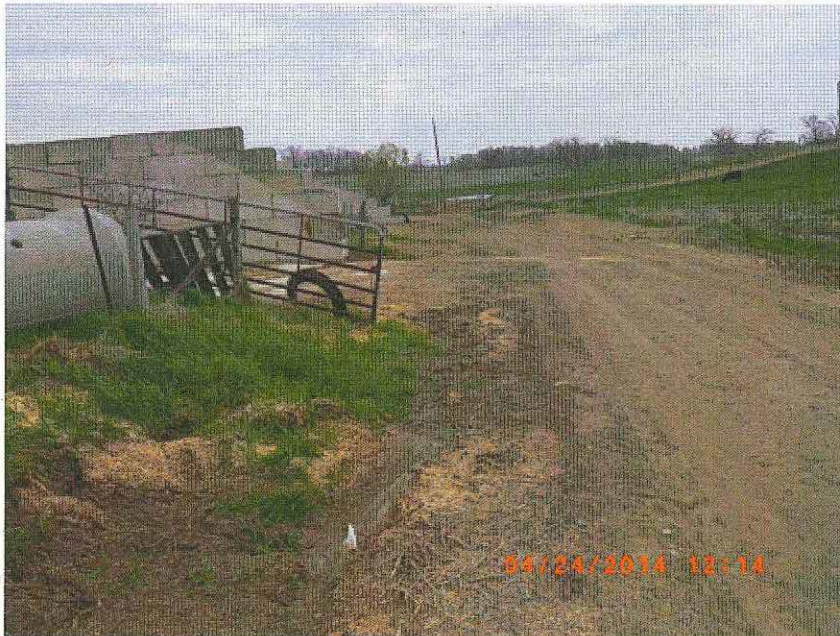
40: IMGP0666

Description: A drainage pathway from the East Lot is sloped to the east.

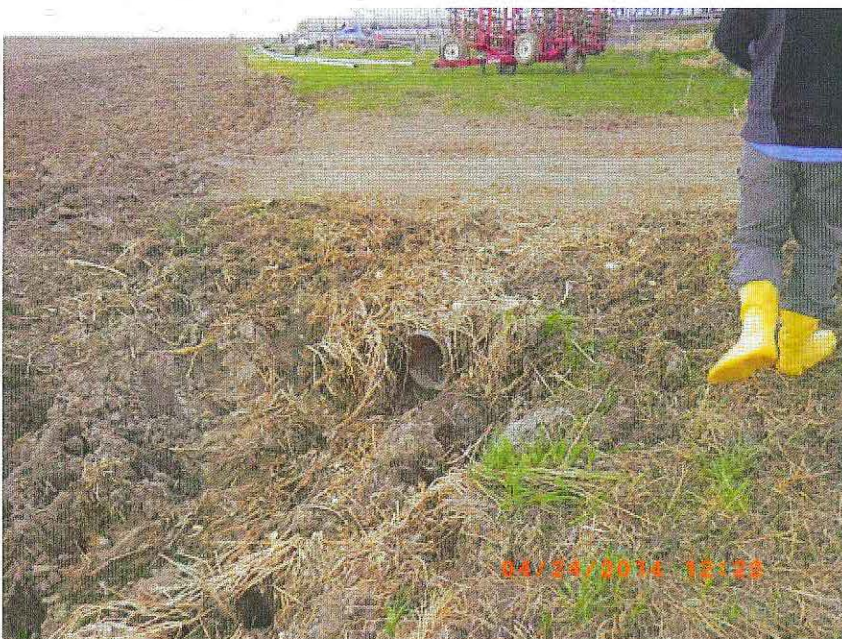
56: IMGP0682

Description: Culvert outlets into pathway.

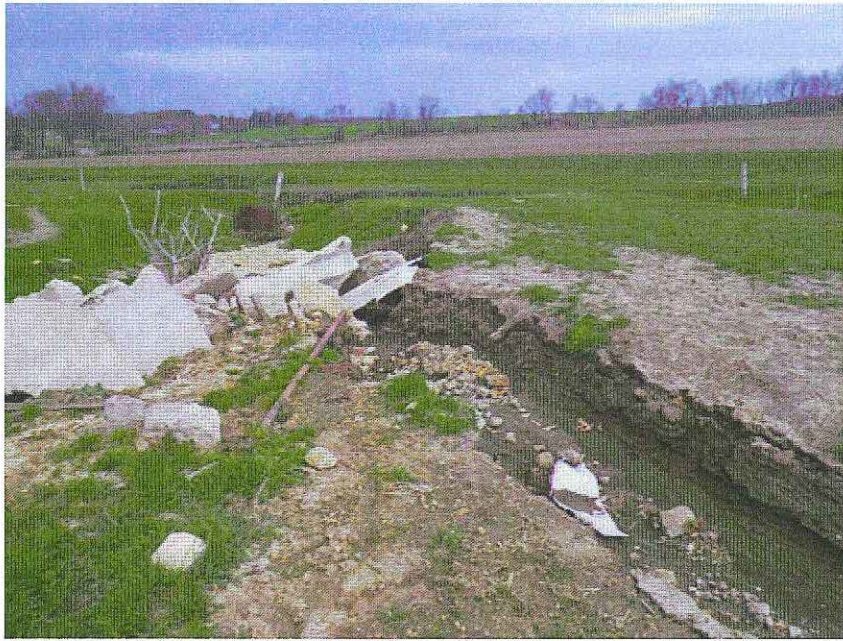
67: IMGP0693

Description: The gully drains to Spring Brook.

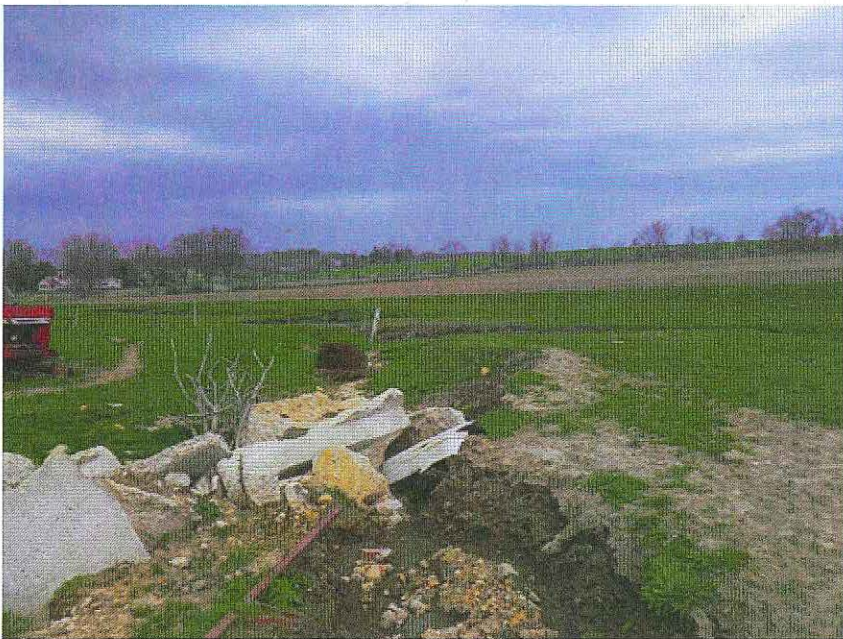
68: IMGP0694

Description: The gully drains to Spring Brook.

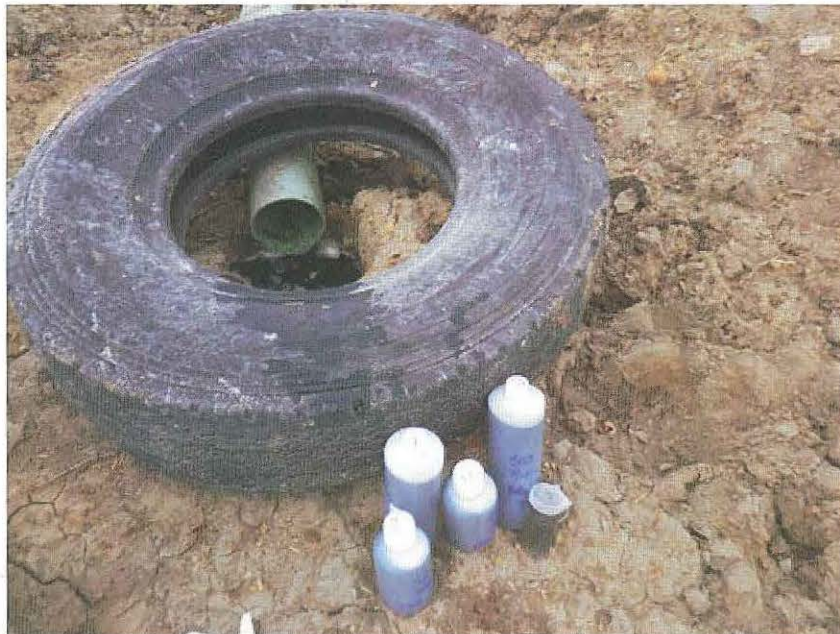
70: IMGP0696

Description: Sample S03 taken from underground tank that accepts drainage from the Feed Bunkers. The water was dark and smelled septic.
